# Meeting the Geotechnical Challenges at two Mongolian Mining Corporation Coal Mines

Presentation to Bowen Basin Open Cut Geotechnical Society  
(BBOCGS)

John Latilla (AMC) and Batdelger Tumur-Ochir (MMC)

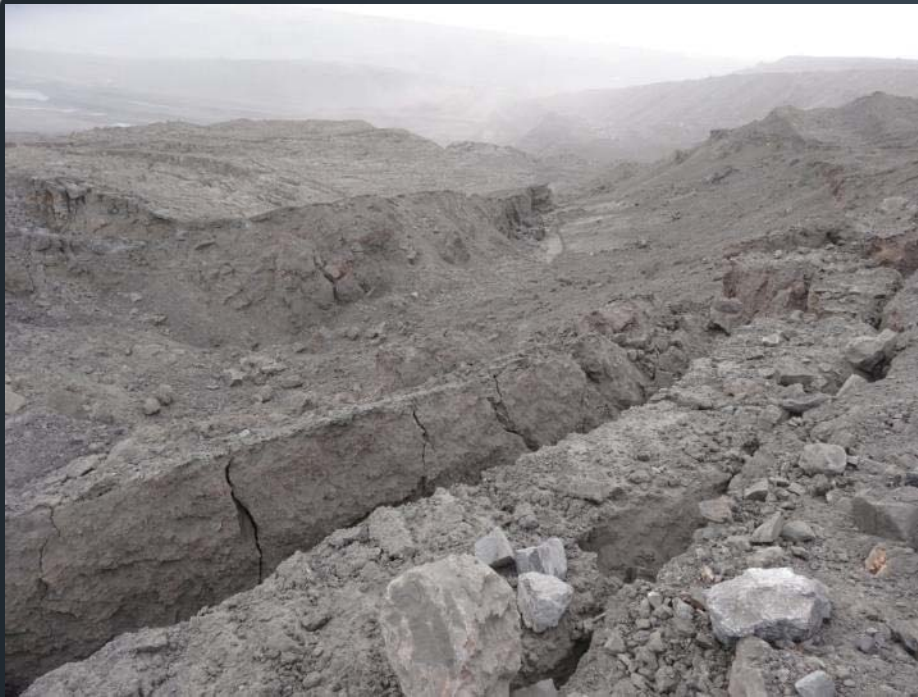
Top of boxcut ramp failure

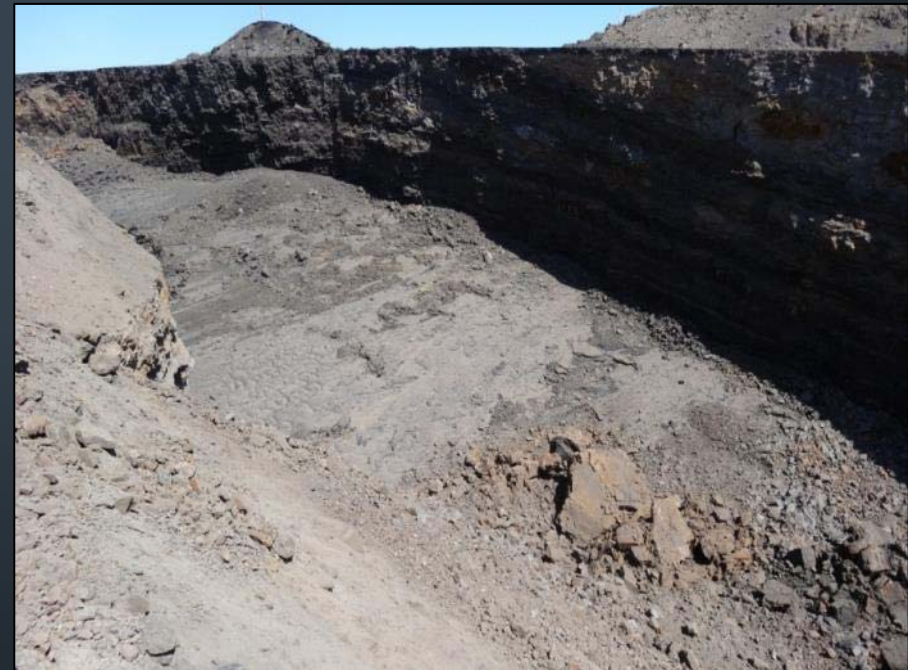
Close-up of bedding shear (dip  $\pm 15^\circ$   
flattening to  $\pm 8^\circ$  towards failure toe)

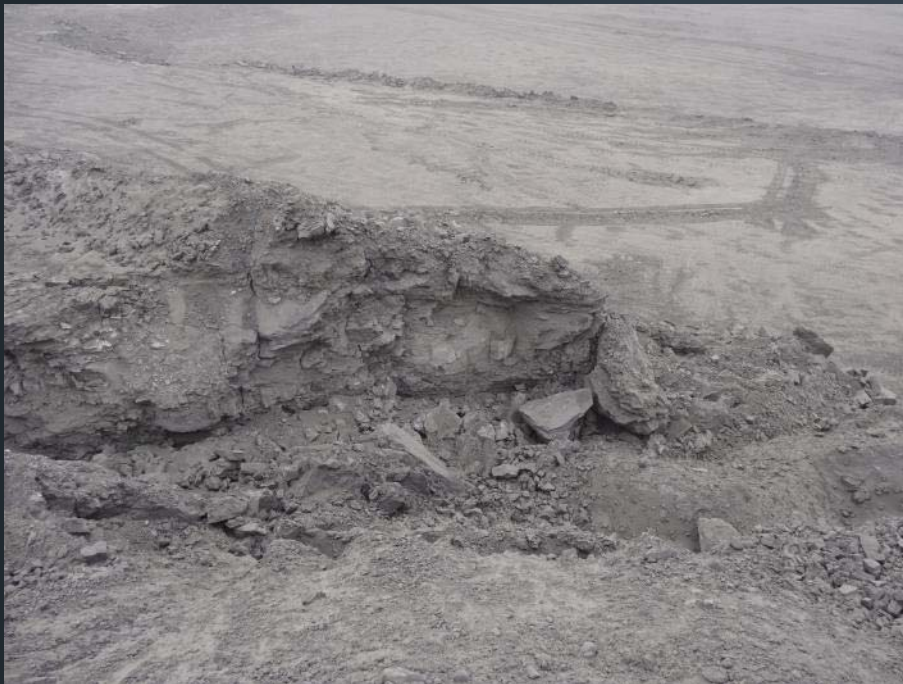
Near bottom corner of failure

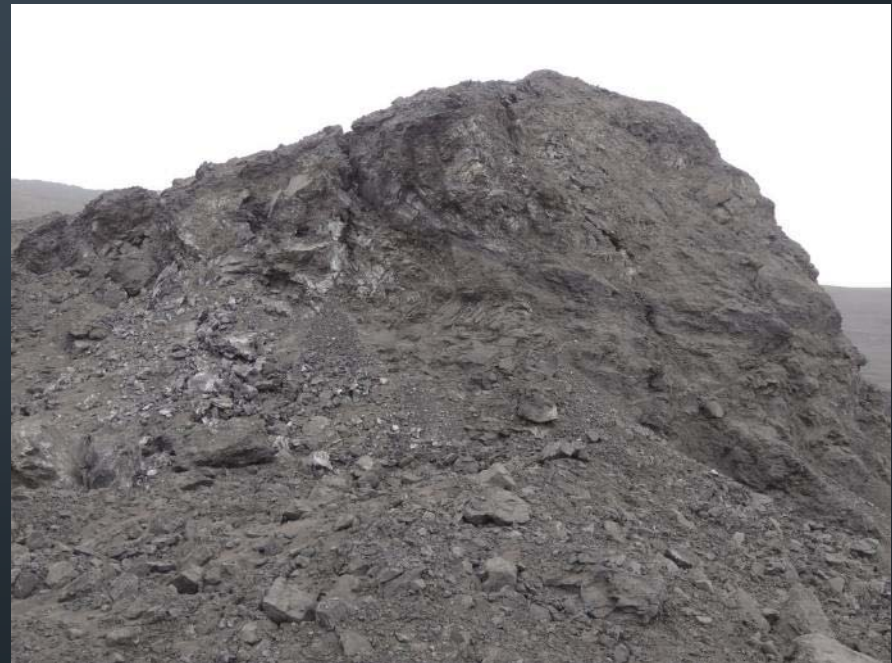
Sheared and faulted zone along part of the eastern flank of failure

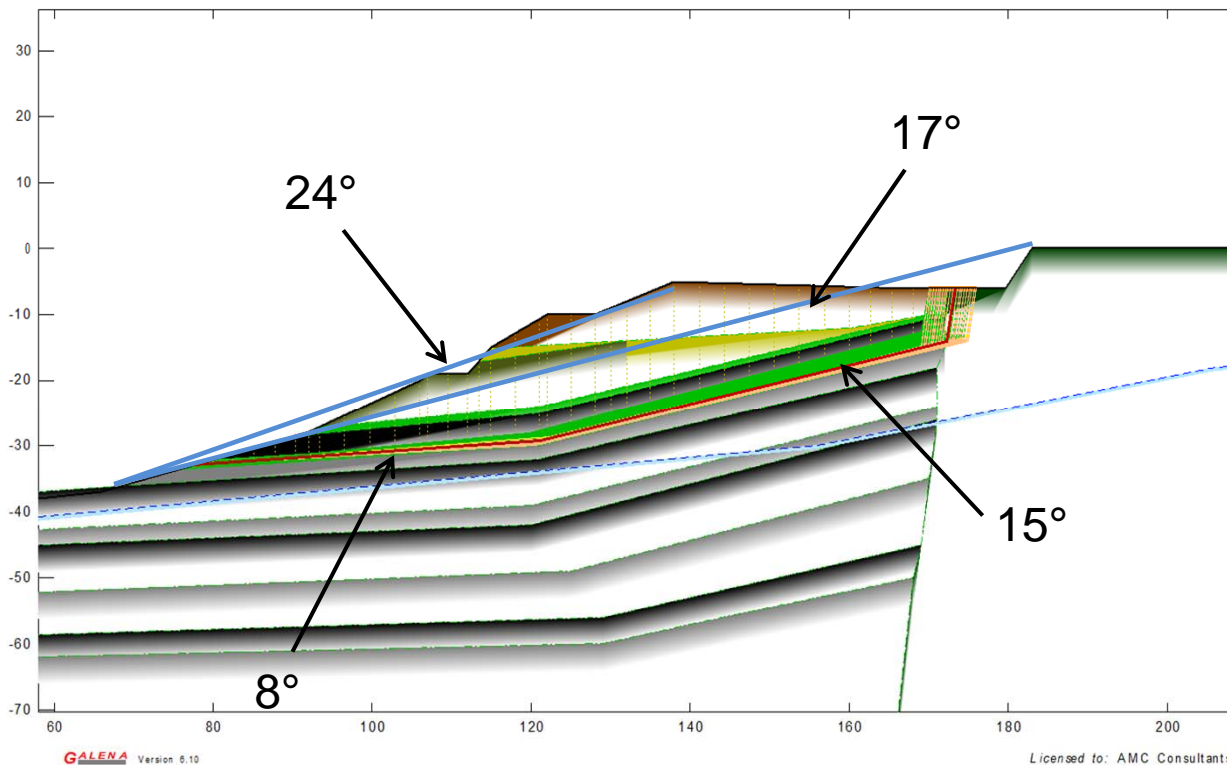
## N Boxcut Ramp Galena Cross Section

Critical Factor of Safety: 1.03  
 Interslice Force (Final) Angle: 11.6°

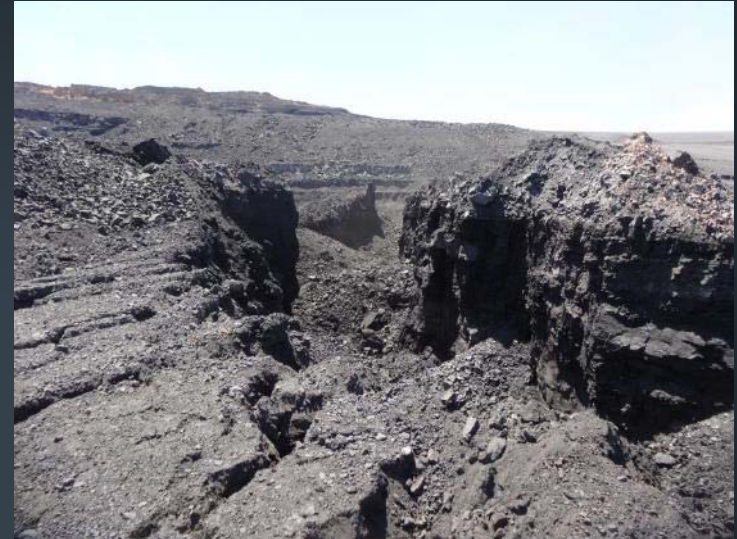
Crack through ramp at base of failure

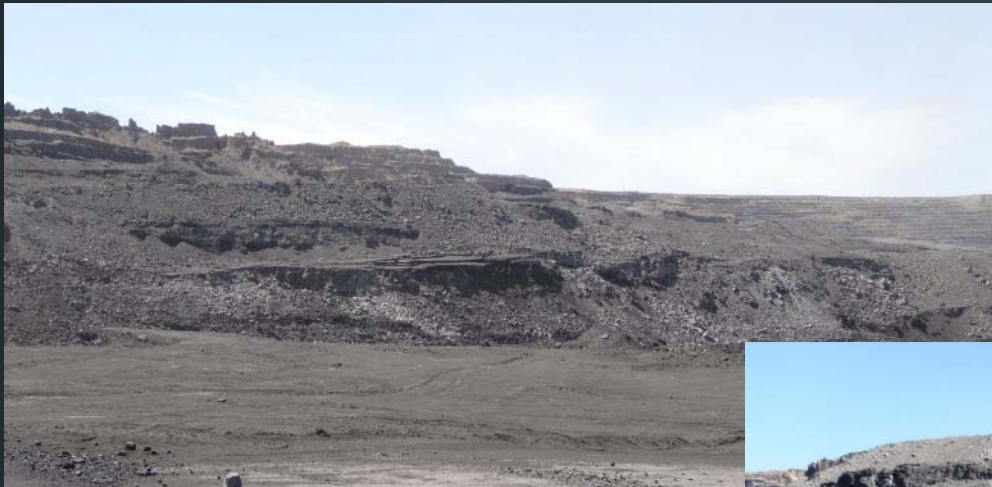
Front face of failure

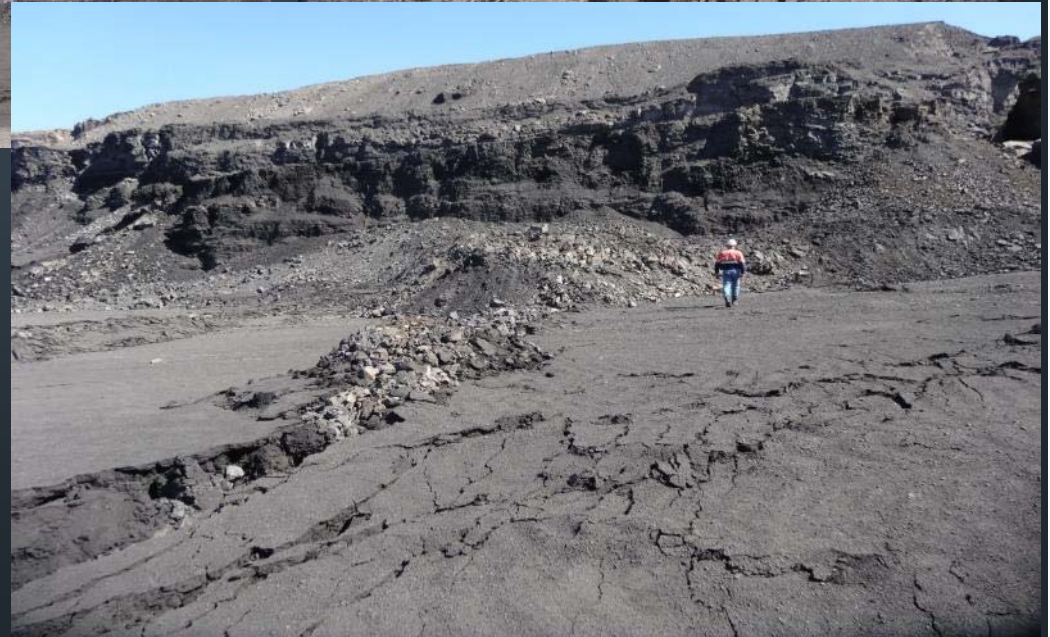
Compression features along top edge of failure

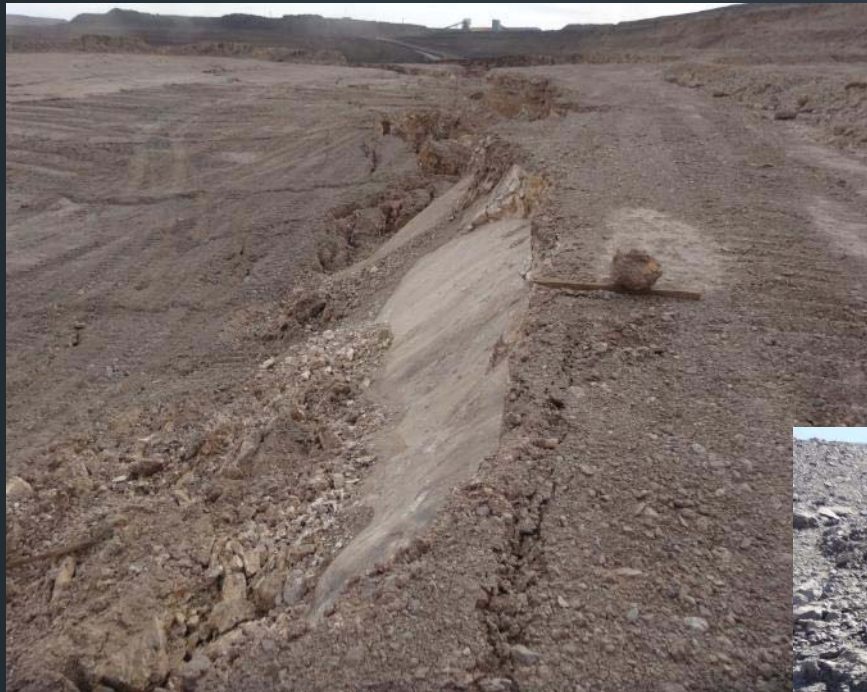
Crest failure and jointing – remains of  
crack meter

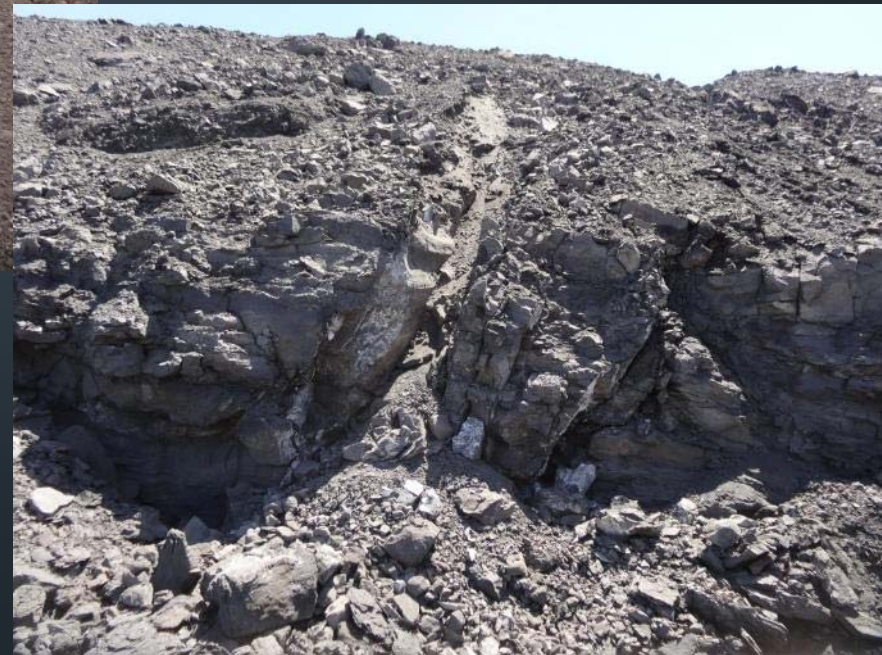
Shear zone on south west side of  
failure – horizontal striations

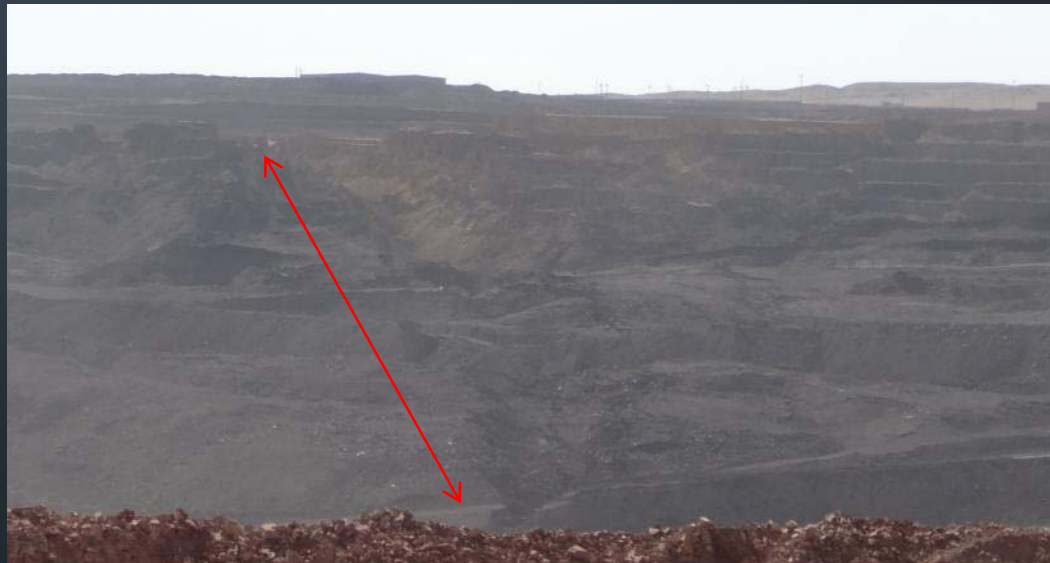
Major axis along shear zone

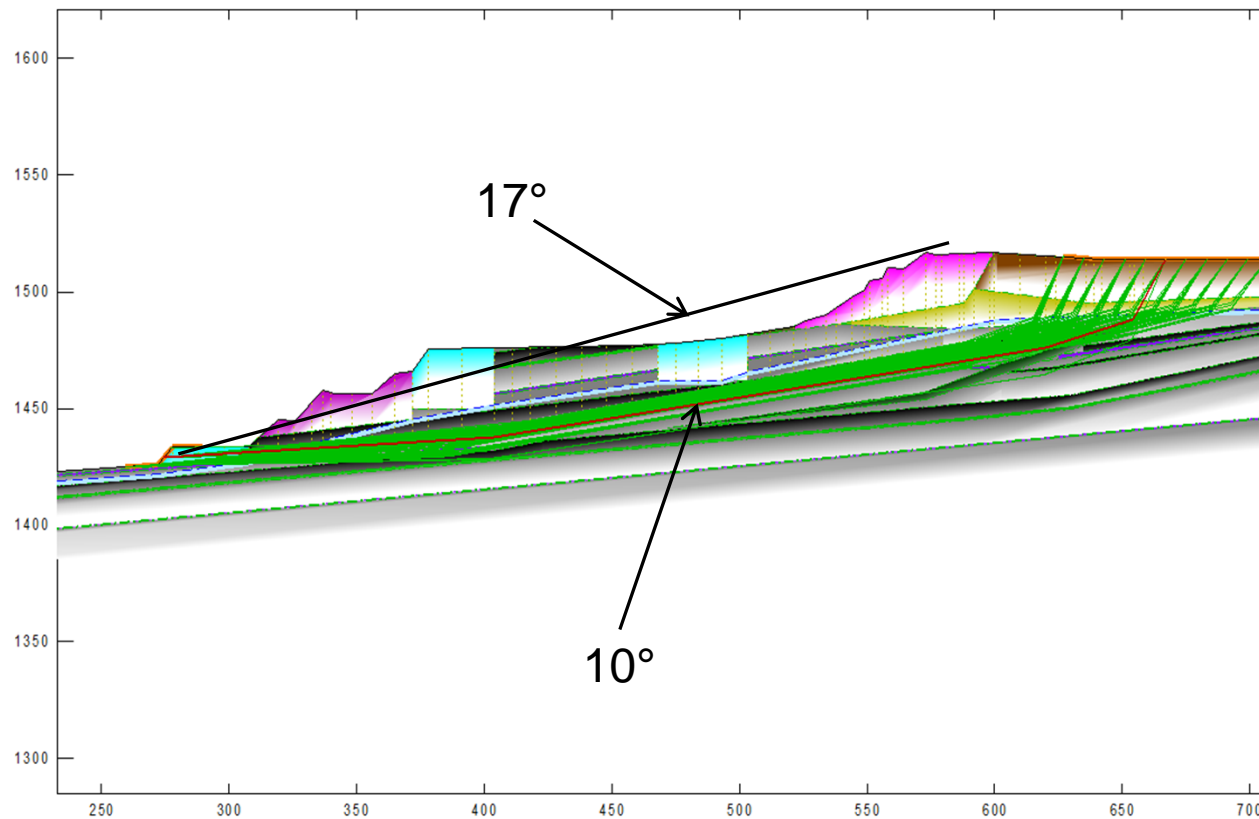
## S Endwall Failure Galena Cross Section

**Results**  
 Critical Factor of Safety: 1.38  
 Interslice Force (Final) Angle: 9.1 °

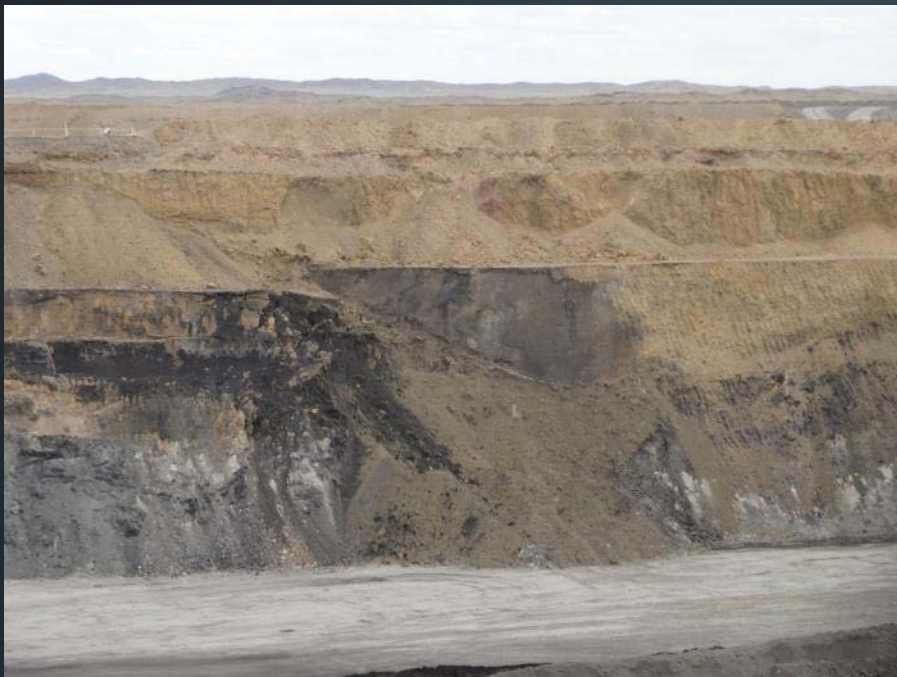
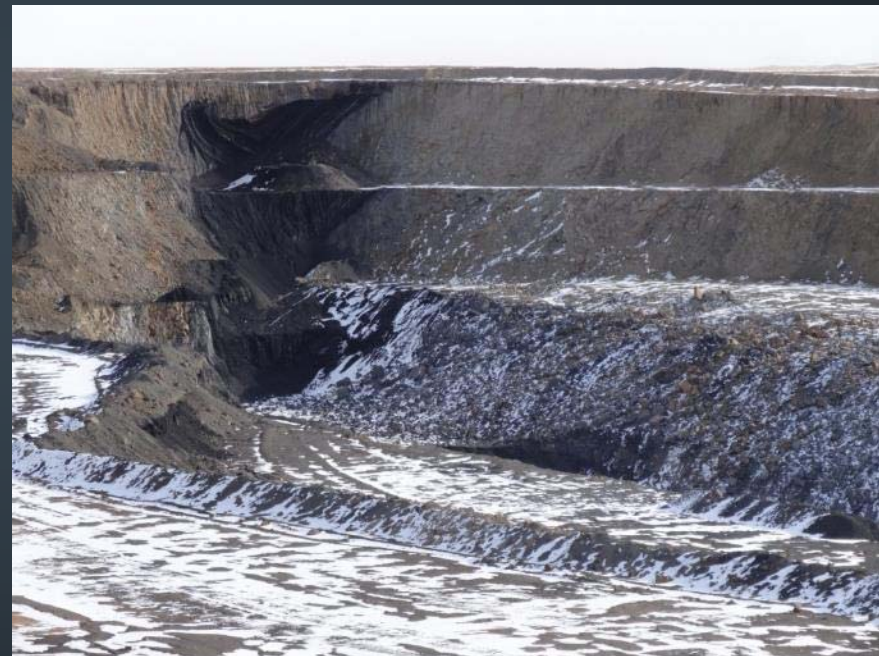
Failure along  
bedding  
close behind  
face
