# Meeting the Geotechnical Challenges at two Mongolian Mining Corporation Coal Mines

Presentation to Bowen Basin Open Cut Geotechnical Society  
(BBOCGS)

John Latilla (AMC) and Batdelger Tumur-Ochir (MMC)

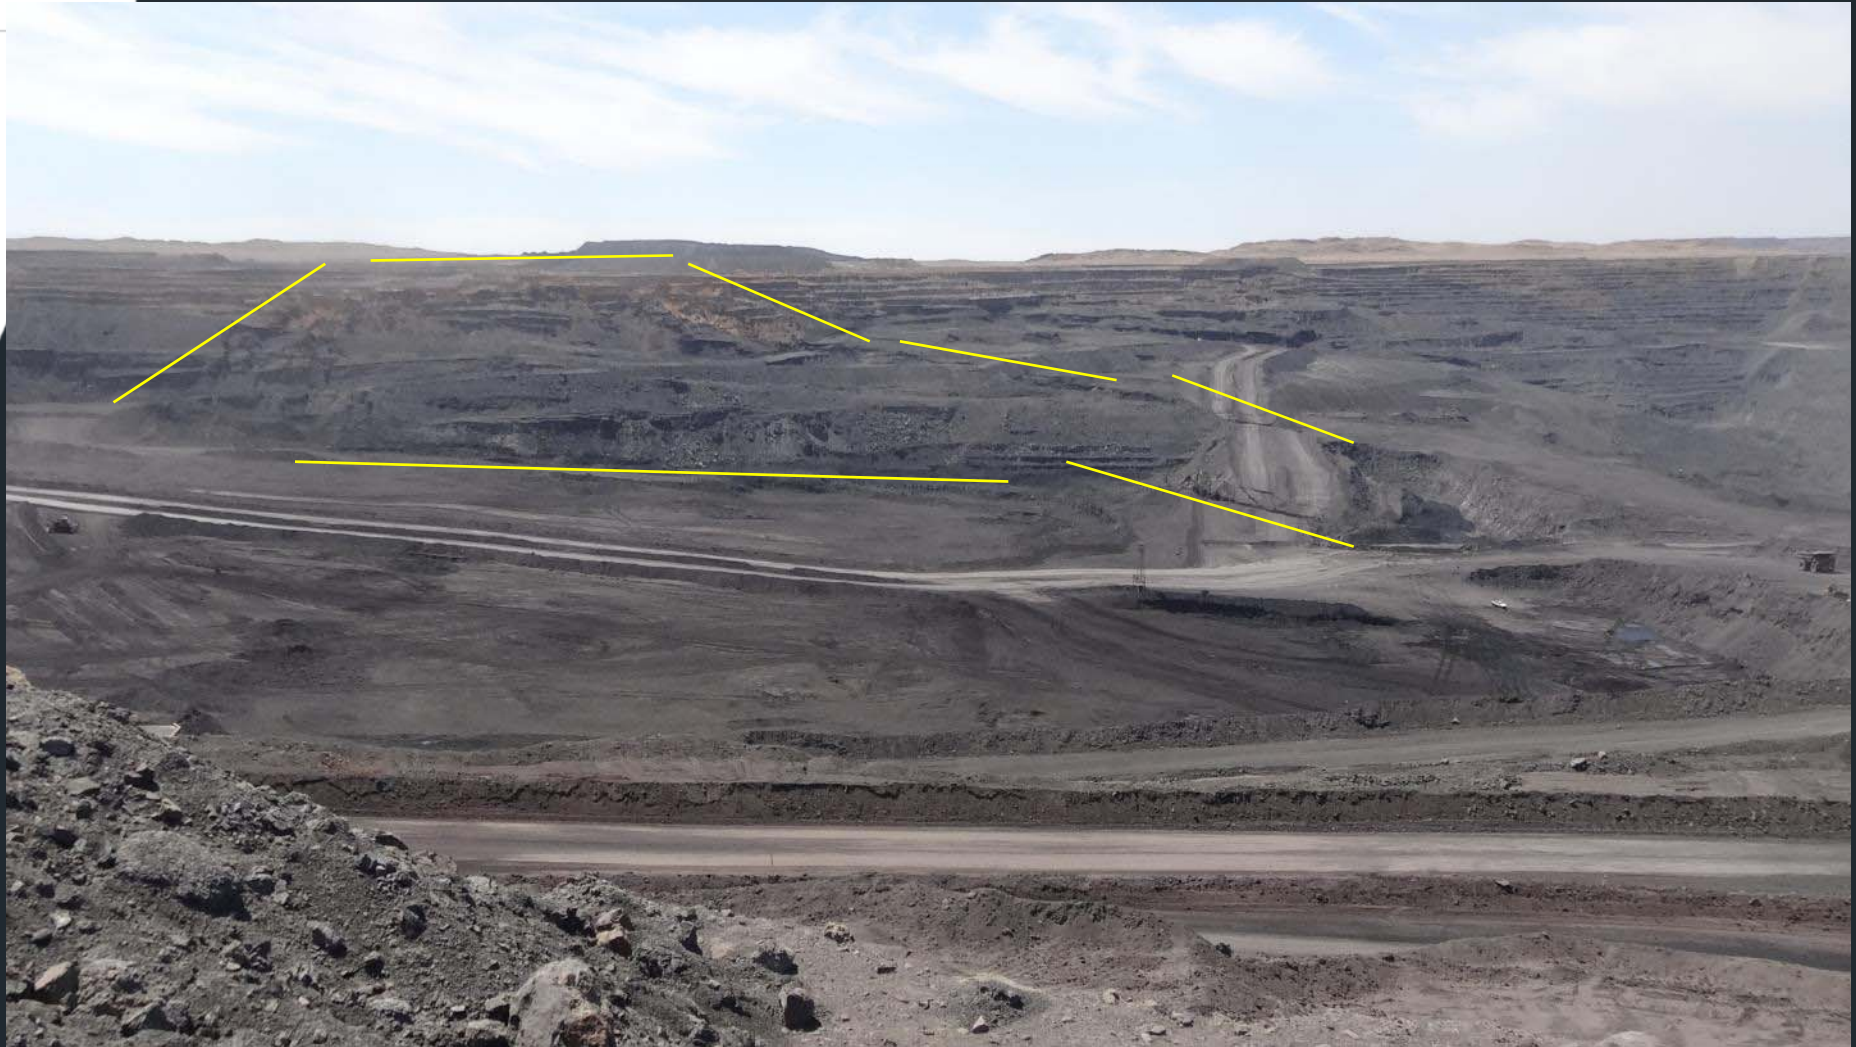
Panoramic view

## Failure Examples, #2 Southern Endwall

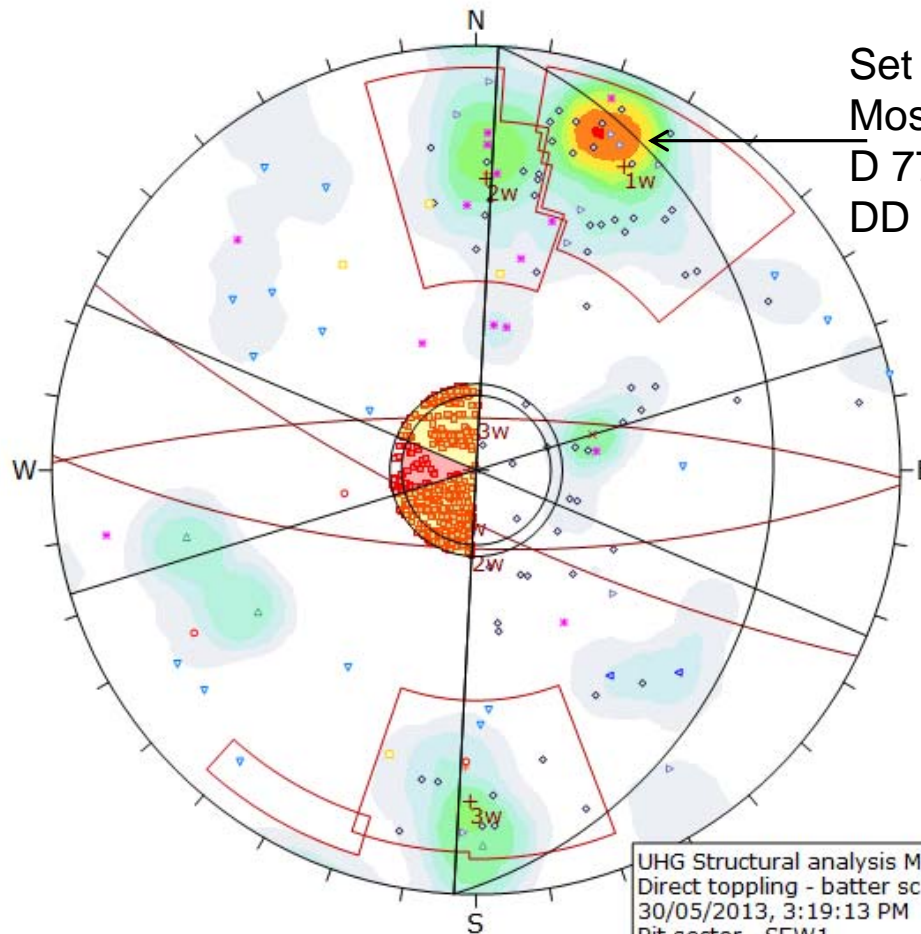
S Endwall Sector SEW1 (Characterised by Steeply Dipping and Folded Strata)

Set 1  
Mostly BP  
D 77°  
DD 206°

Kinematic Analysis	Direct Toppling
Slope Dip	20
Slope Dip Direction	93
Friction Angle	23°
Lateral Limits	20°

Critical	Total	%
Direct Toppling (Intersection)	237	92846	0.26%
Oblique Toppling (Intersection)	3352	92846	3.61%
Base Plane (All)	2	433	0.46%
